**Final Research Report**  
Agreement T4118, Task 39  
Landscape Phase 3

**IN-SERVICE EVALUATION OF MAJOR URBAN  
ARTERIALS WITH LANDSCAPED MEDIANS—  
PHASE III**

June 2013

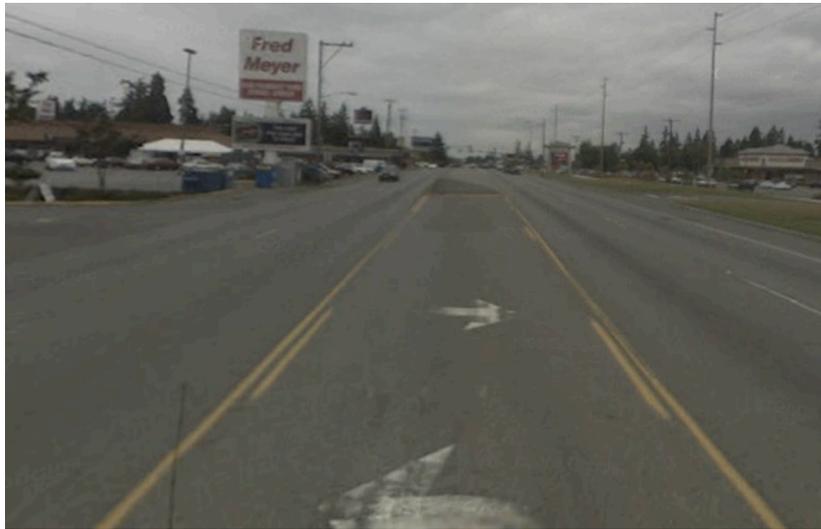
**Figure 1: Example of a Two-Way Left Turn Lane (TWLTL) with Limited Access Control<sup>1</sup>**

The typical historic cross-section of SR 99 within the metropolitan region consisted of five to seven lanes, including a center, two-way left turn lane (TWLTL). In general, the paved shoulders were wide, with sidewalks present at only a few locations. Figure 1 shows an example of a typical roadway section with TWLTL and minimal access control.

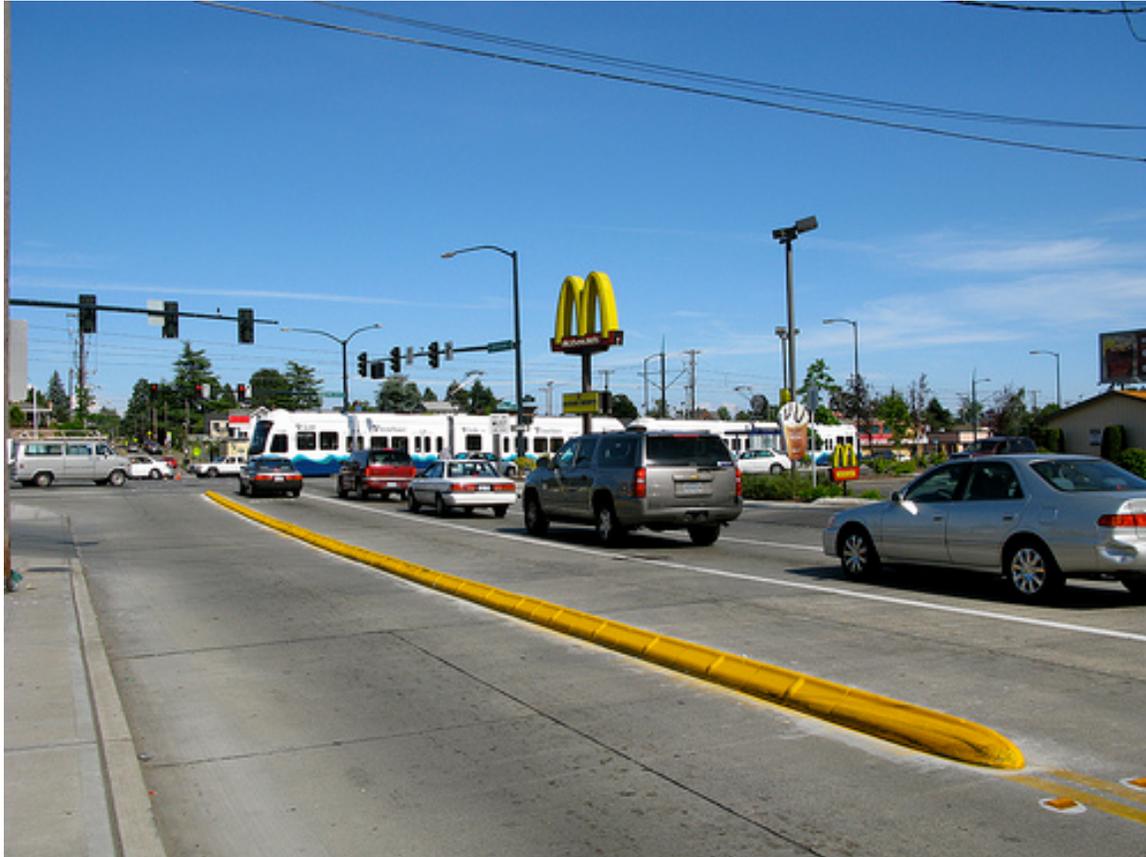
**Figure 2: Example of a C-Curb<sup>2</sup> Separating Directions of Traffic**

Access to commercial and private properties was minimally controlled. At a few locations there was no TWLTL or a low, asphalt-covered median and C-curb (see Figure 2) separating the two directions of traffic. At many intersections, dedicated right and left turn lanes existed. In general, the aspect was of a wide, uncontrolled asphalt streetscape
